## Failure analysis on domestic pipeline

**Keywords:** Non-revenue water; non-destructive testing; black body

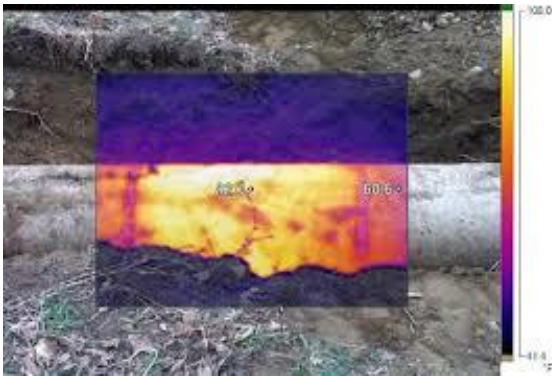
Thermographic analysis of the pipes shows the location of defect on bad pipe more clearly. The high temperatures reading on the pipe indicate the crack location.

Figure 1 Defect location using thermographic analysis.

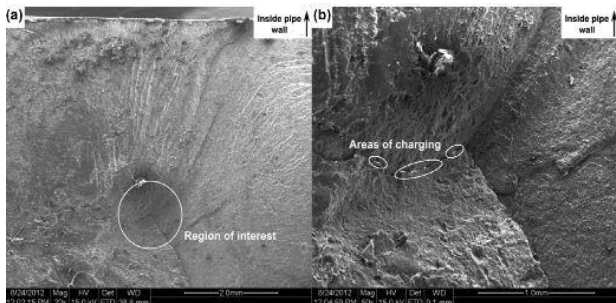
Figure 2 SEM image of cracks (high magnification).

following the same procedure as used previously. As shown in Figure 2, the defect responsible for crack initiation in this case was a void in the pipe wall, approximately 0.45 mm wide. Three cracks can be seen to radiate out from the void. While this void has been identified as the stress riser that led to crack initiation and eventual failure of the pipe, it is unclear what caused the defect originally. For example, it is possible that the observed void was attributed to a particle or agglomeration of particles that were removed during fracture and subsequent failure. Alternatively, the void may also have been the result of air that was trapped within the pipe during extrusion or uneven shrinkage due to temperature gradients during cooling following pipe extrusion.

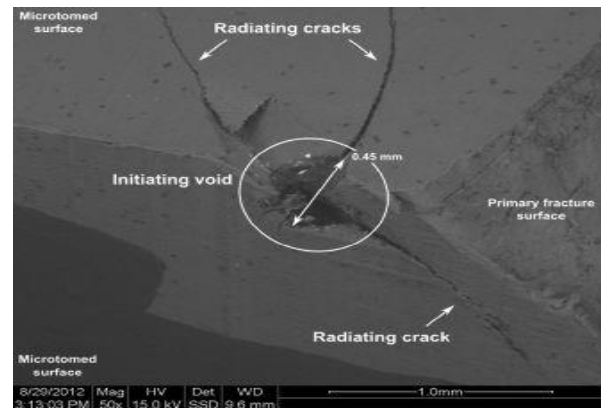
Initial observations of fracture failures in bad pipe suggest that in the majority of cases, voids or foreign inclusions in the pipe wall provide localized stress risers which lead to crack initiation under remote stress. However the initial assessment of the fracture surface, inspection, visible light microscopy unable to identify the stress riser at the source of the fracture. More detailed inspection was undertaken using Scanning Electron Microscope (SEM) to provide a higher magnification image and qualitative chemical analysis of any inclusions found. Figure 1 (a) and (b) shows higher magnification of the fracture initiation region.

Figure 3 Primary fracture surface.
