# Charpy impact response of oil palm empty fruit bunch fiber reinforced metal laminate system

**Keywords:** oil palm empty fruit bunch; fiber metal laminate; charpy impact

**ABSTRACT** – The low velocity impact response of novel oil palm empty fruit bunch fiber reinforced metal laminates system has been investigated. The specimens were tested using a pendulum impact tester according to ASTM E-23 in a flatwise direction. Impact resistances of the fiber metal laminates were benchmarked with monolithic aluminum. The main failure mechanism after impact had been investigated with detailed microscopic observation. Finally, it was found that energy absorption of aluminum is higher than fiber metal laminates.

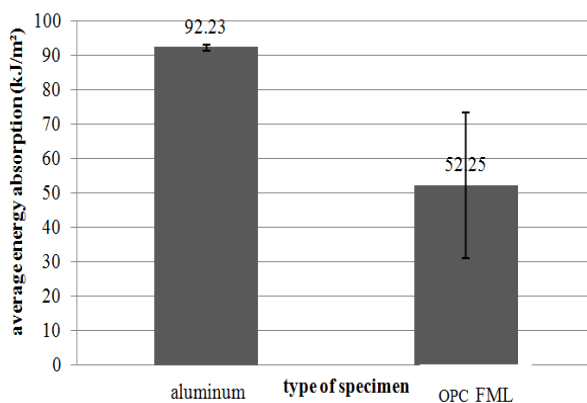
Figure 2 Energy absorption for each material

Figure 2 shows the average energy absorption for OPCFML and aluminum impacted in a flatwise direction at room temperature. In this experiment, aluminum is generally able to absorb higher energies compared to OPC FML material. The low energy absorption of FML can be contributed to weak bonding between the aluminum and composite laminates.

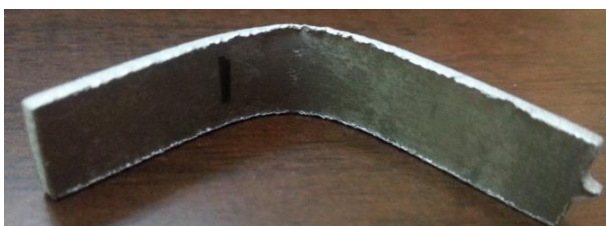
Figure 3 Failure mechanism of aluminum

Figures 3 and 4 show the specimens after impact for both materials. The main failure mechanisms are different. Figure 3 shows the main failure mechanism on the aluminum material was damaged at the region of the line of impact.

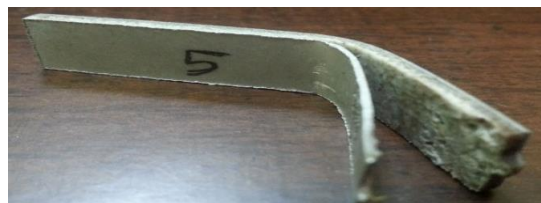
Figure 4 Failure mechanism of OPC FML

As can be seen in figure 4, plastic deformation of the aluminum layer and delamination are observed at the location of impact and are detected as the failure mechanism. No aluminum tearing was observed. Due to the high rate strain at the impact location, the sequence of the failure mechanisms is difficult to recognize, but the initial failure is due to delamination, then fiber breakage and metal failure [1].
